Agilent 2100 Bioanalyzer

Maintenance and Troubleshooting Guide

Agilent Technologies

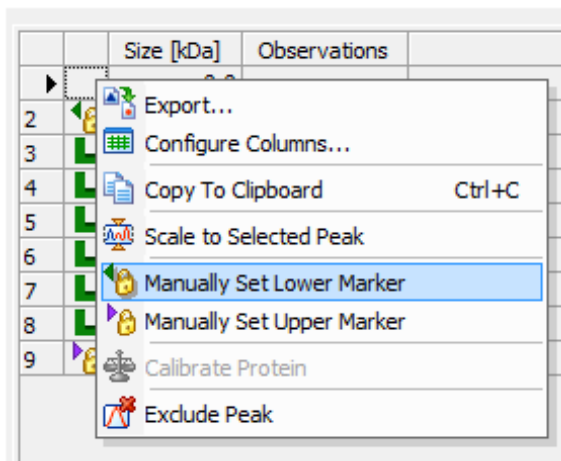
- 3 To adjust the lower marker, right click on the correct peak, and choose **Manually Set Lower Marker**.

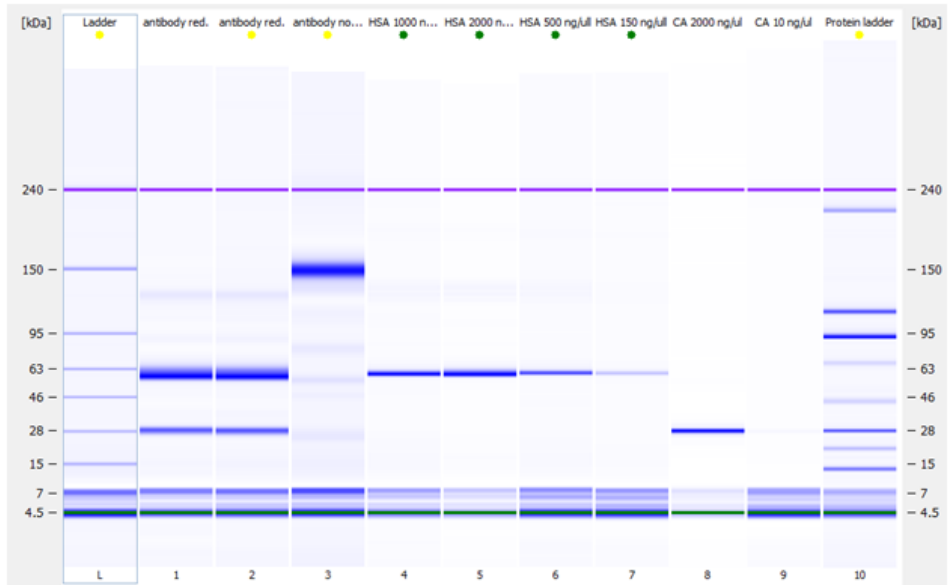
The data is properly aligned after the markers are called correctly.
